Eastbank Condominiums, North Hudson, WI

DRYER DUCT BOOSTER® INSTALLATION & RESULTS

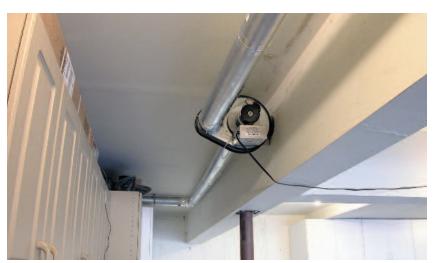
Interior clothes dryer duct runs included many elbows and an excessive linear duct length

The dryer duct run consisted of thin walled aluminum flex duct in the interior mechanical room with many elbows, bends and sags between the duct hangers. The duct run through the garage utilized expandable aluminum corrugated pipe and was approximately 20' long. There were a total of seven 90 degree

elbows and five 45 degree elbows plus approximately 39 straight feet of duct.

Considering that one 90 degree elbow equals six straight feet and one 45 degree elbow equals three straight feet, there was approximately 96 equivalent feet of duct on the dryer run. What's more, the resistance of corrugated duct, versus straight non-corrugated metal duct, increased the total equivalent feet of duct to 120 feet. Most dryer manufacturers allow a maximum of 25 equivalent feet of duct.

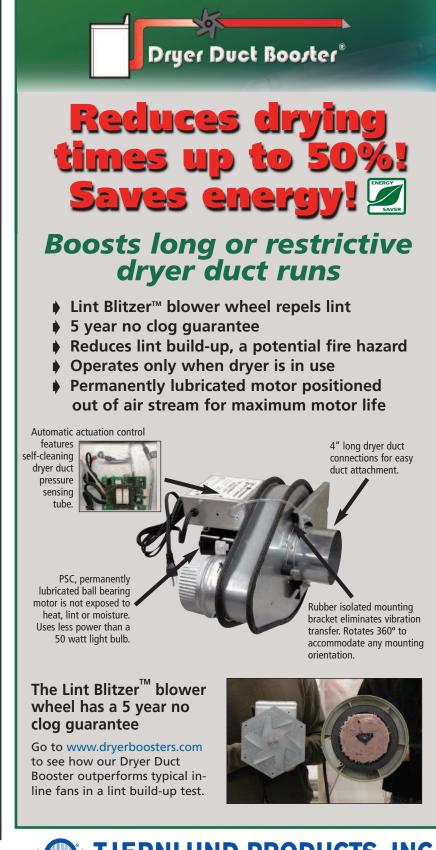
Exterior duct run with Dryer Duct Booster® installed in the garage. Duct was changed out from corrugated aluminum flex duct to rigid metal duct.

Dryer Duct Booster® can be installed in horizontal or vertical duct runs. Mounting bracket also allows Dryer Booster to be rotated 360 degrees for installation flexibility.

The homeowners installed a Tjernlund in-line Dryer Duct Booster® fan and also changed aluminum flexible corrugated duct runs in garage over to rigid metal duct to bring the total equivalent duct length under 100 feet. They were impressed with the Duct Booster's construction, superior engineering, quietness plus ease of installation—which only took 15 minutes! During the initial startup, increased exhaust velocity created by the Duct Booster dislodged a large amount of lint trapped in the duct and forced it out the exterior vent.
