TJERNLUND PRODUCTS, INC.

MODEL (950-0625) SS1 REPLACEMENT MOTOR WITH WHEEL KIT INSTRUCTIONS

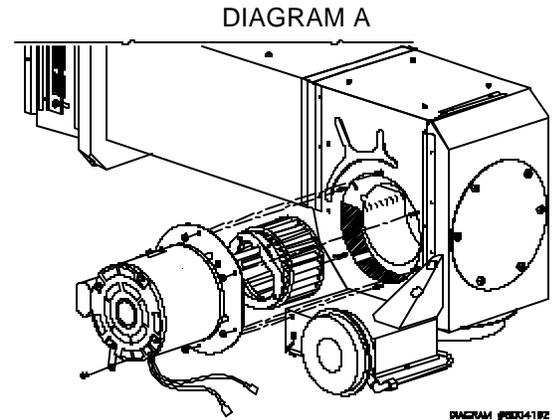
For the steps following below, refer to diagram A.

1. Remove electrical box cover and disconnect (2) motor leads.
2. Remove and save (1) motor bracket screw from electrical box.
3. Holding the motor, apply firm pressure towards the plenum of the SideShot and remove and save the (6) motor mount nuts. **Note: Hold the assembly firmly; failure to do so could damage internal parts.**

4. Slide motor/wheel assembly from Plenum. Grasp only the motor casing; do not damage wheel, shaft or other components on Plenum. Do not rest assembly on wheel.

5. Install new motor/wheel assembly into Plenum with leads facing electrical box. Use caution when inserting motor/wheel assembly into Plenum to avoid wheel damage. Firmly fasten motor to plenum using (6) nuts removed in step 3 above.

6. Route wires from motor into electrical box. Slip BLACK onto terminal "M" and WHITE onto terminal "L2" of terminal strip.
7. Reinstall (1) motor bracket screw removed from step 2 above.

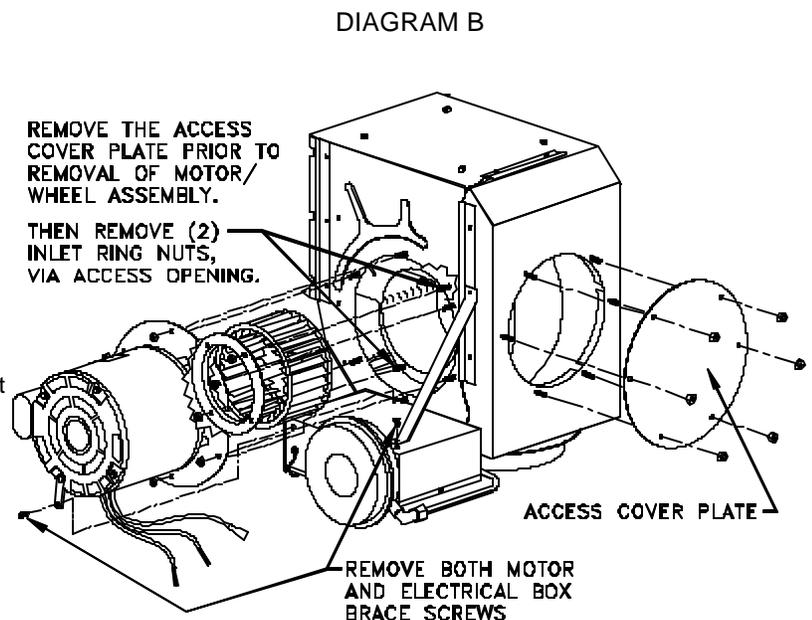
For the steps following below, refer to diagram B.

1. Remove electrical box cover and remove (3) motor leads.
2. Remove and save (2) motor & electrical box brace screws.
3. Remove and save (2) nuts from inlet collar on housing inside plenum. **Note:** Removal of plenum access cover plate will allow for removal of inlet collar nuts with 11/32" box end wrench.
4. Push down electrical box about 1/4" so motor mount plate can clear junction box. Once motor mount plate has cleared the studs it can be rotated so motor mount plate flat aligns up with junction box for easier removal.
5. Holding the motor, apply firm pressure towards the plenum of the SideShot and remove and save the (6) motor mount nuts. **Note:** An 11/32" box end wrench is used for nut directly under electrical box. **Note: Hold the assembly firmly; failure to do so could damage internal parts.**

- Slide motor/wheel assembly from Plenum. Grasp only the motor casing; do not damage wheel, shaft or other components on Plenum. Do not rest assembly on wheel.

For the steps following below, refer to diagram B.

- Install new motor/wheel assembly into Plenum with leads facing electrical box. Use caution when inserting motor/wheel assembly into Plenum to avoid wheel damage. Firmly fasten motor to plenum using (6) nuts removed in step 5.

- Replace plenum access cover plate and tighten (6) nuts removed in step 3.
- Reinstall motor and electrical box brace screws removed from step 2.
- Route BLACK and WHITE wires from motor into electrical box. **Note:** A ground wire is not included on these replacement motors. The motor is grounded by contact with the Plenum and ground wire from terminal strip to Plenum.

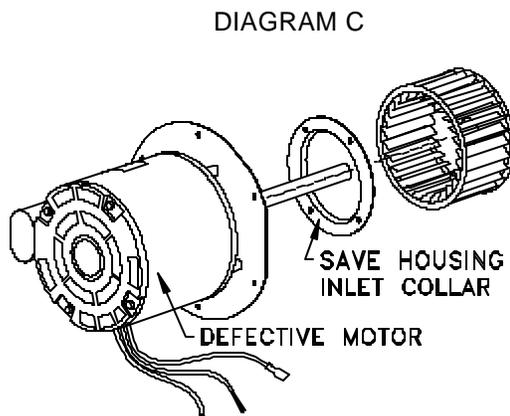
For the steps following below, refer to diagram C.

- Loosen set screw from wheel hub with 5/32" allen wrench.
- Twist wheel to loosen and pull off of motor shaft. Wheels "fused" to shaft may require penetrating oil and/or a wheel puller to facilitate removal. Discard old wheel when removed. **Important:** The housing inlet collar from old motor will have to be removed and saved for use with the new motor.

- Loosen set screw with 5/32" allen wrench and remove wheel from new motor.
- Remove and save (4) nuts from the new motor mounting plate and remove from motor. Leave spacers on motor studs.
- Remove (2) screws which hold spring ring inlet collar assembly to mounting plate and discard spring ring inlet collar assembly.
- Secure motor to mounting plate with (4) nuts removed in step 10. **Important:** The capacitor of the motor should be opposite the flat edge on motor mounting plate.
- Place inlet collar removed in step 8 over new motor shaft so embossed edge will be facing wheel cavity, (See Diagram C).

- Place wheel on new motor shaft with wheel cavity facing motor and firmly tighten set screw on flat of shaft, (See Diagram C).

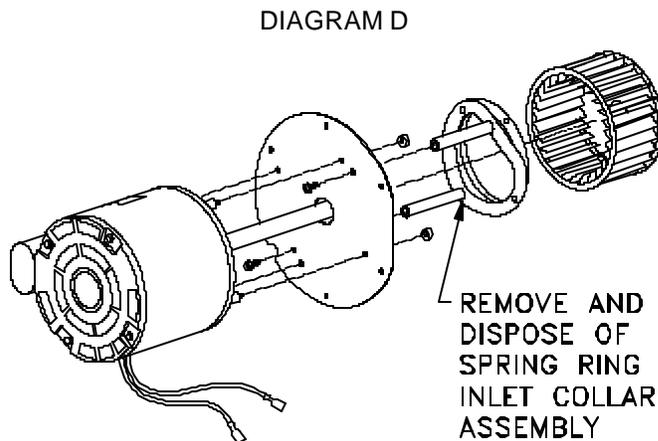
For the steps following below, refer to diagram D.

The new motor/wheel with spring ring inlet collar assembly is only compatible with SideShots with date codes after 9518. The following modifications will have to be made to adapt the motor/wheel assembly to the SideShot with date codes between 9226 and 9517.
