Project Case History

High performance, low profile draft inducing system cures backdrafting and sightline issues

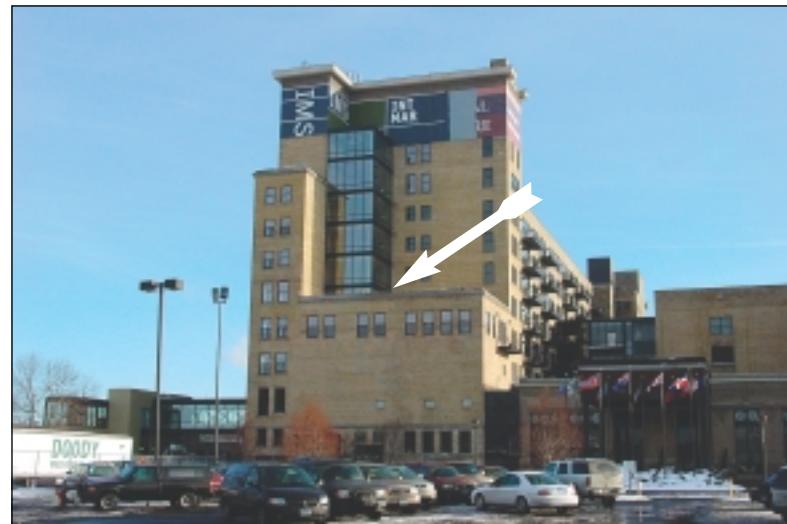
Arrow points to roof where wind swirled to create downdraft and boiler shutdowns prior to installing a mechanical draft system using Tjernlund's modulating draft inducer and CPC-3 Constant Pressure Controller.

After verifying the equipment was installed per design specifications, Brengman concluded that down drafts were being caused by a combination of prevailing winds and the building's exterior geometry.

"The stacks were located on the roof of a five story section adjacent to an 11 story tower. When high northwest wind hit the building, it swirled and air was forced down the stacks creating a negative pressure throughout the ventilation system out the combustion air louvers," explained Brengman.

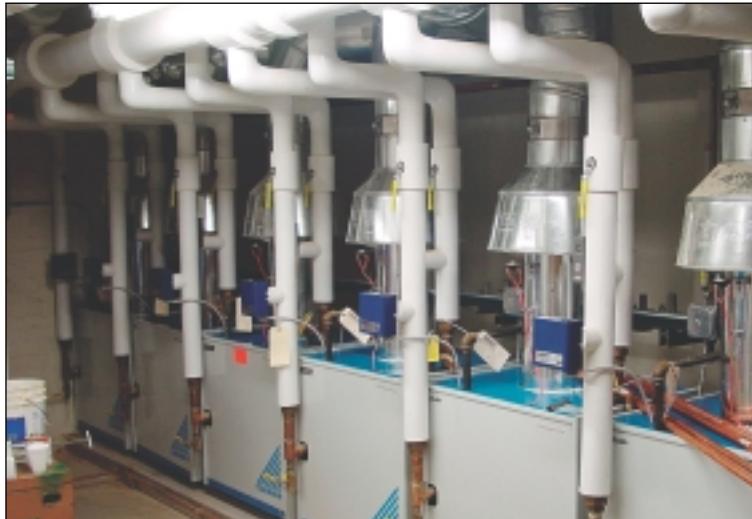
Above: Tjernlund's VSAD Auto-Draft Inducer terminates the stack connected to six boilers. It is controlled by a CPC-3 Constant Pressure Controller.

The mechanical draft system selected was made by Tjernlund Products. Components consisted of a VSAD variable speed Auto-Draft® Inducer mounted on the roof, and a CPC-3 Constant Pressure Controller with a Variable Frequency Drive and an auto-calibrating pressure transducer.

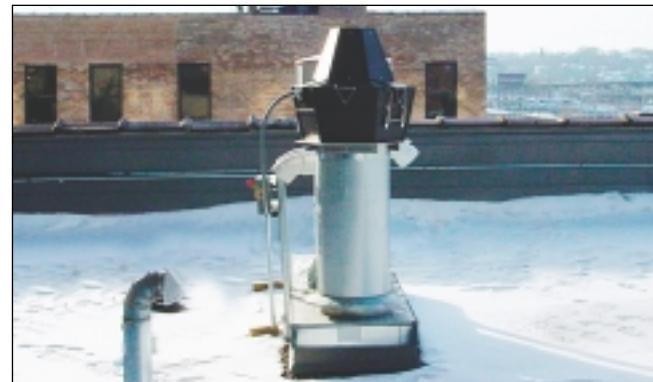
Left: Six boilers in the International Market Square Building are vented via a single stack by a Auto-Draft Inducer.

To keep costs down, Brengman had Doody reconfigure the two stacks so all six boilers were tied into a common stack and one power venting system was needed instead of two.

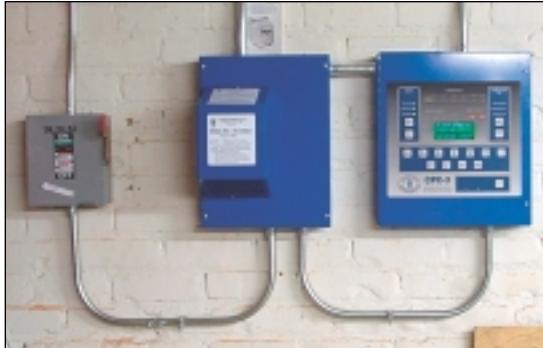
The Tjernlund System controls include VFD in the middle and CPC-3 Constant Pressure Controller on right

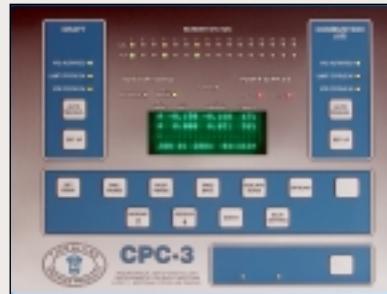
Tjernlund CPC-3 Features:

- Large lit display and easy to use soft touch keypad.
- Primary functions can be programmed via dedicated keys, eliminating scrolling through multiple screens.
- Additional LED's indicate limit(s) status, VFD operation and fault status.
- Correct Inducer/Blower rotation is determined by display prompts and changed through DIP switches on the circuit board.
- System fault diagnosis readout and retrieval.
- Built-in alarm alerts building maintenance personnel if system faults. Alarm relay also allows interface with building management system.
